Examples of Work Zones

The following are examples of past work zones that illustrate both good and bad examples of pedestrian and cyclist accommodation in work zones. Each example discusses the pros and cons of the work zone and highlights where improvements could be made to make the accommodations safer and more convenient for active users.

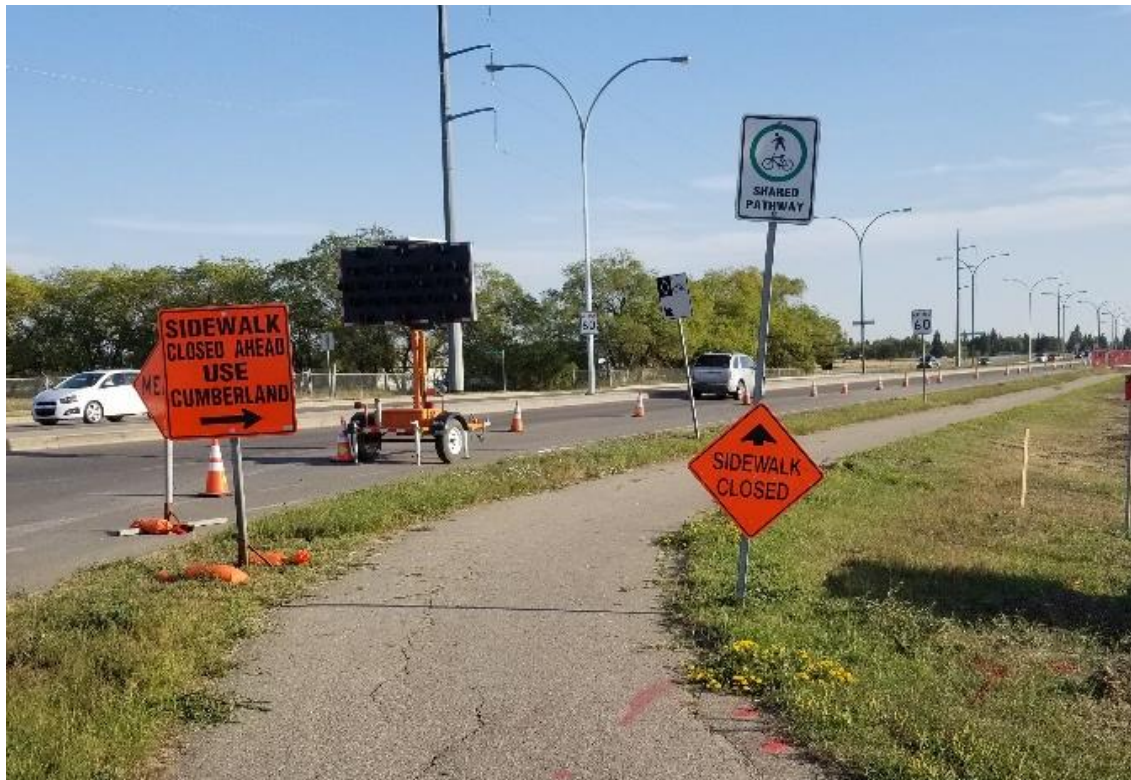
The guidance provided at the closure directed pedestrians and cyclists approaching from the north to use Cumberland Avenue, but no facility was available along College Drive to facilitate this movement. Further, no information regarding the distance of the detour was provided nor was advance signage placed to advise pedestrians and cyclists to choose an alternate route.

Image 1: Multi-use pathway closure signs at Preston Avenue and College Drive

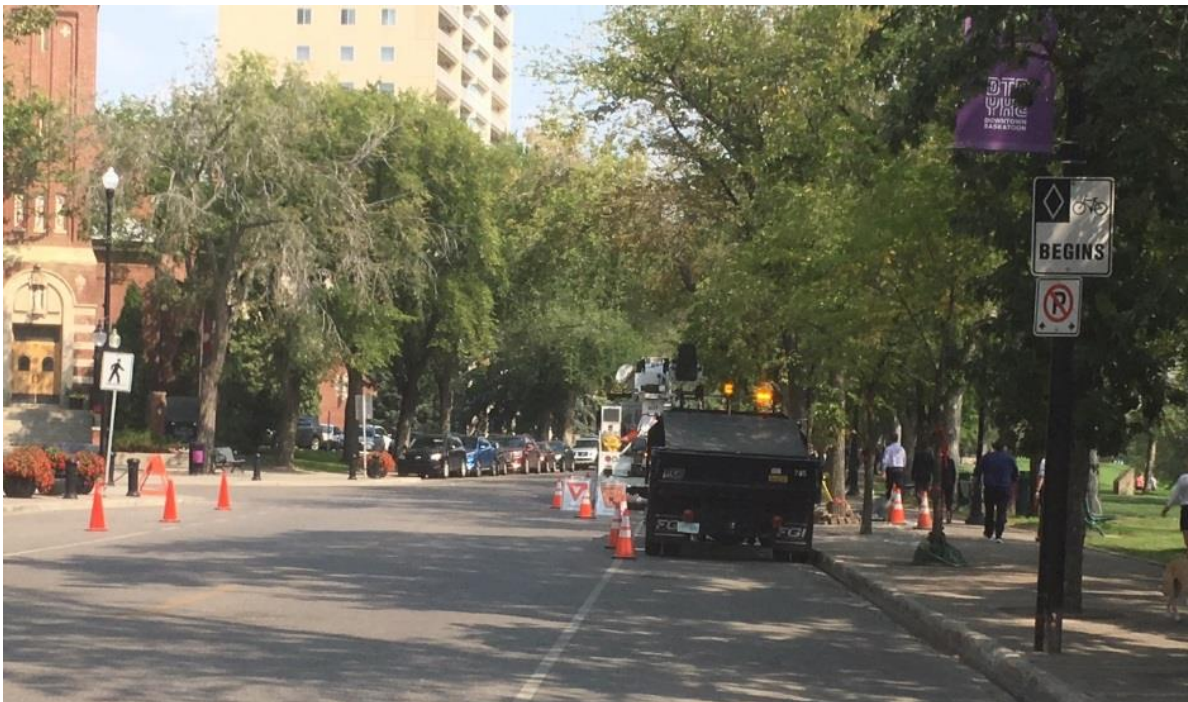
This example involves a short duration temporary closure of the bicycle lane along Spadina Crescent. To complete minor repairs, temporary closures or diversions may be required for short periods of time. It is important that the needs of pedestrians and cyclists are taken into consideration in these types of closures as well. In this particular instance, the temporary traffic control was improperly implemented. Signs were placed too close together, there was a lack of taper to direct traffic, and guidance was not provided to cyclists to indicate that the bike lane was closed, and that cyclists and motorists must share the traffic lane. The addition of signs communicating the closure of the bike lane and expected travel behaviour for both vehicles and cyclists would improve the safety of all road users in this type of temporary traffic control.

Image 4: Lack of signage directing cyclists and vehicles to share the traffic lane

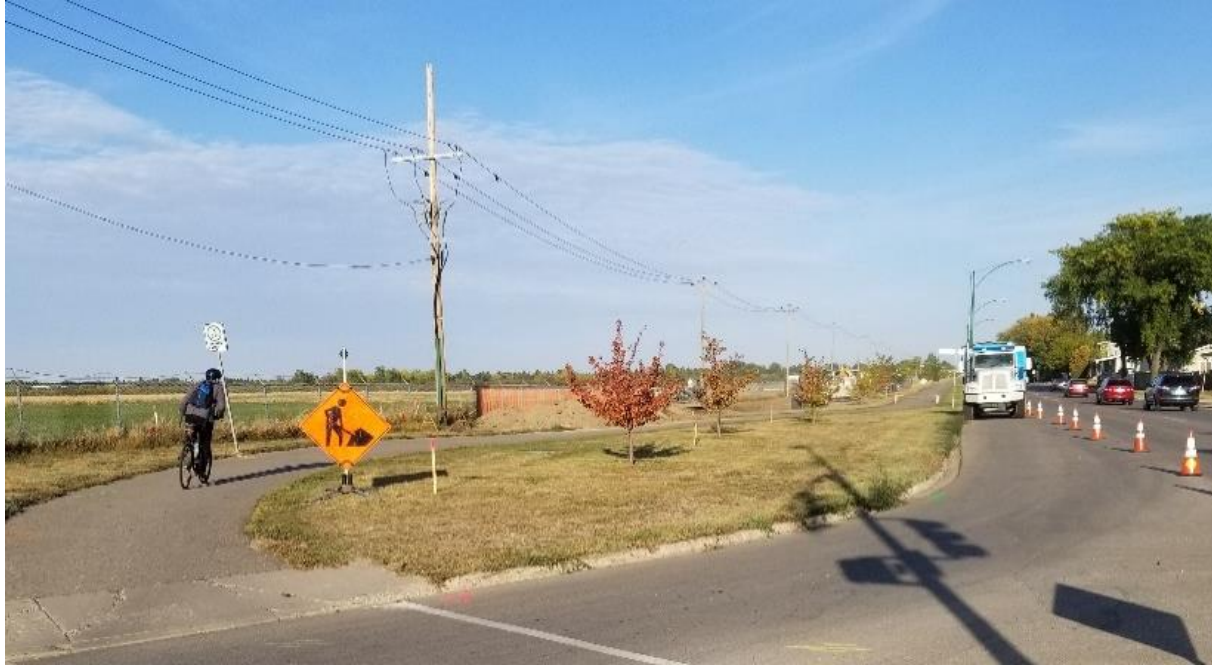
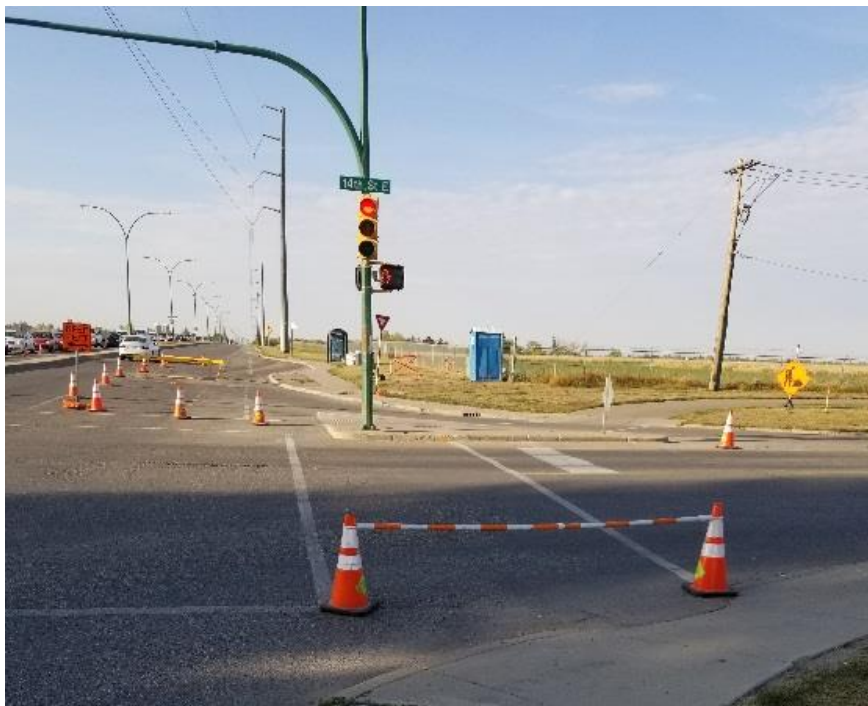
This detour is an example where a third-party was doing work adjacent to the multi-use pathway along 14th Street. The work zone lacked signage indicating that the area is restricted and there was no guidance directing cyclists and pedestrians to an alternative route.

Image 5 and 6: Lack of signage indicating the pathway is closed

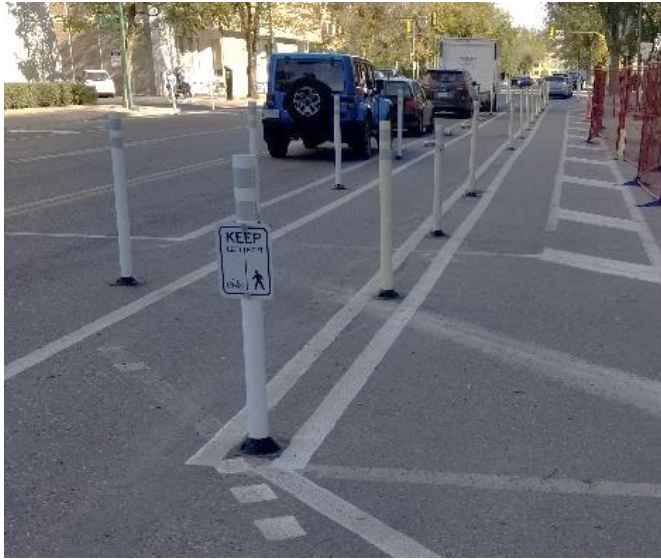
The diversion previously in place in front of the former Police Station on 4th Avenue is a good example of a work zone accommodation for pedestrians, cyclists and vehicles that meets the intent of the proposed policy. This diversion respected the needs of all road users by replicating, as nearly as is practicable, the facilities that the work zone is disrupting. Further improvements to this diversion would include better accommodations for people with low vision or mobility limitations, such as a straight, detectable edge for people with visual impairments and ramps for people using mobility aids. Further, the protected bike lane is fully retained. This diversion is good example of how to provide safe, convenient temporary facilities for pedestrian and cyclists.

Image 7: Human-scaled signage indicating the spaces for pedestrians and cyclists

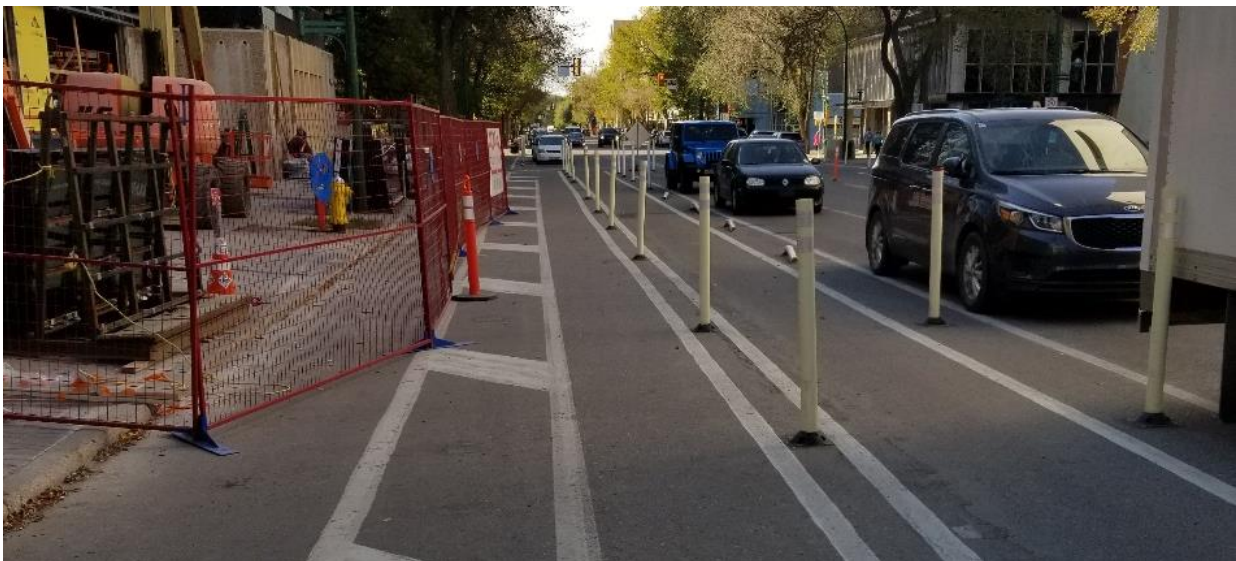
Image 8: Providing a straight, cane detectable edge would improve this diversion for people with visual impairments

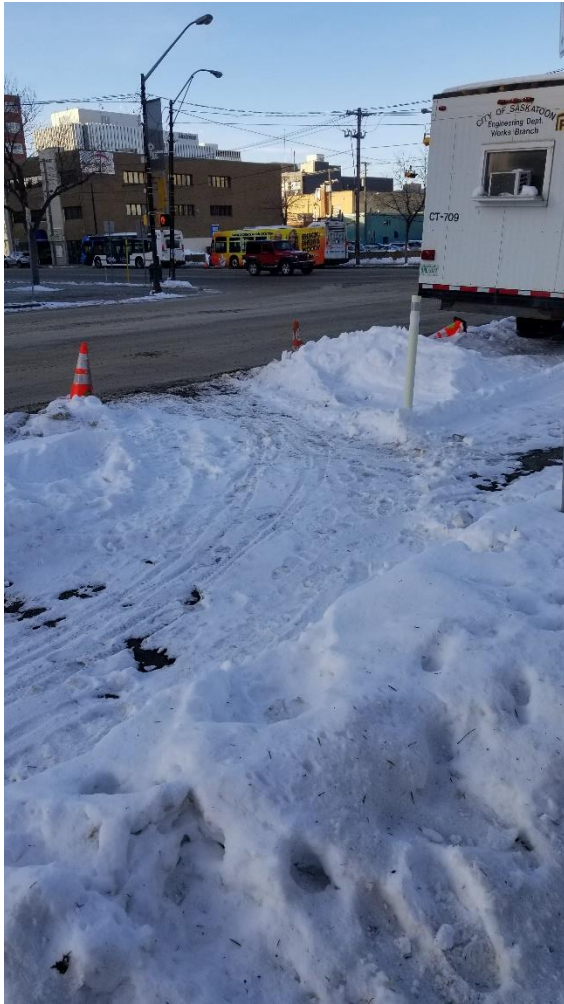
In November 2020, a crew trailer was placed at the corner of 23rd Street and 3rd Avenue for City staff to use during the initial response to the COVID-19 pandemic. This trailer was installed without adequate signage and detour markings. As shown in the photos below, the bike lane was blocked off without any signs being provided to indicate that the lane was blocked or providing guidance to motorists or cyclists on what behaviour was expected through this construction zone. The lack of guidance has resulted in people riding in the bike lane “merging” with traffic just prior to the trailer, creating hazardous conditions for both motorists and cyclists.

Image 11: protected bike lane ends without guidance to cyclists or drivers
